Stream Flow Analysis and Channel Stability on Recently Restored Sevenmile Creek - Comparison before and after restoration

Department of Life & Environmental Sciences, Carroll College, Helena, Montana

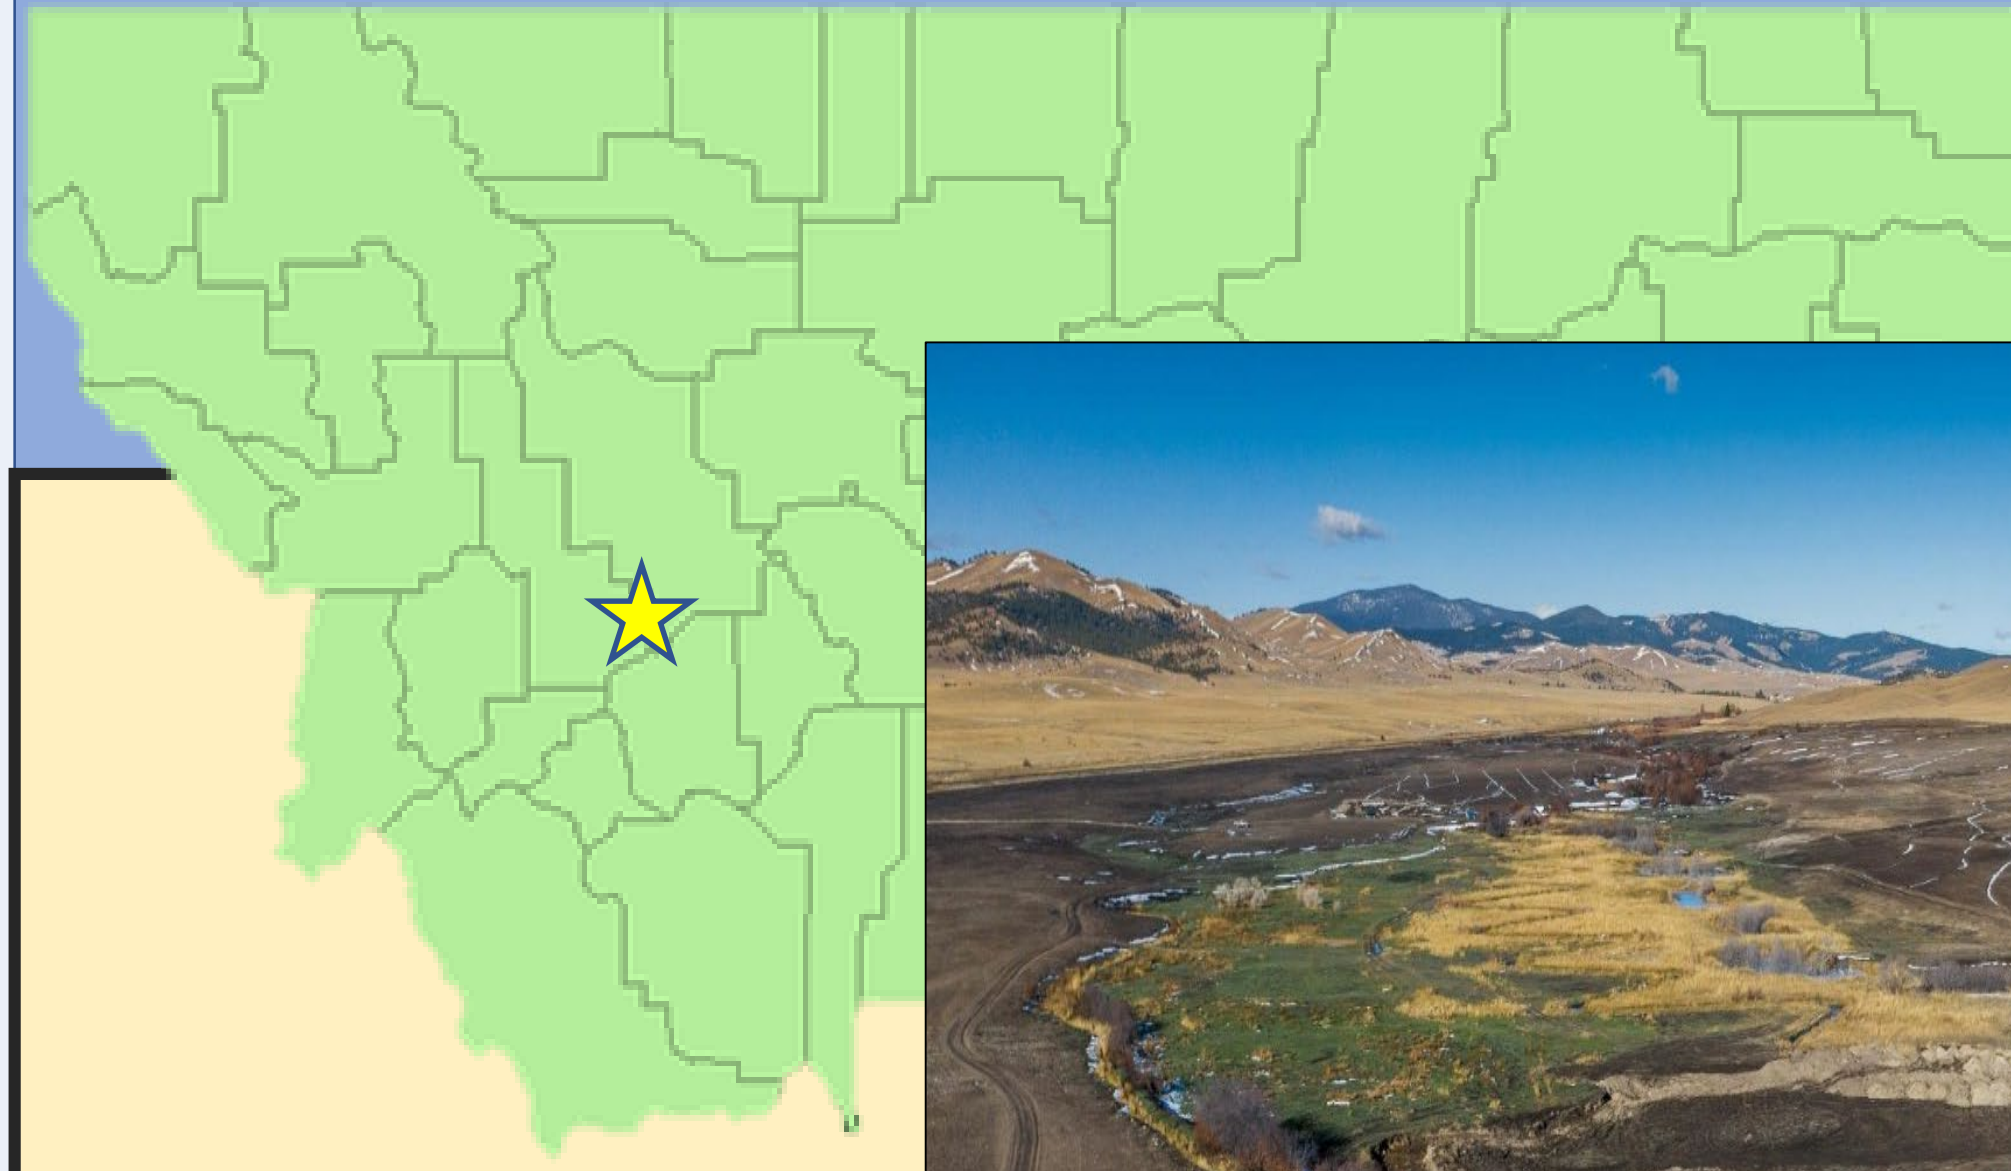
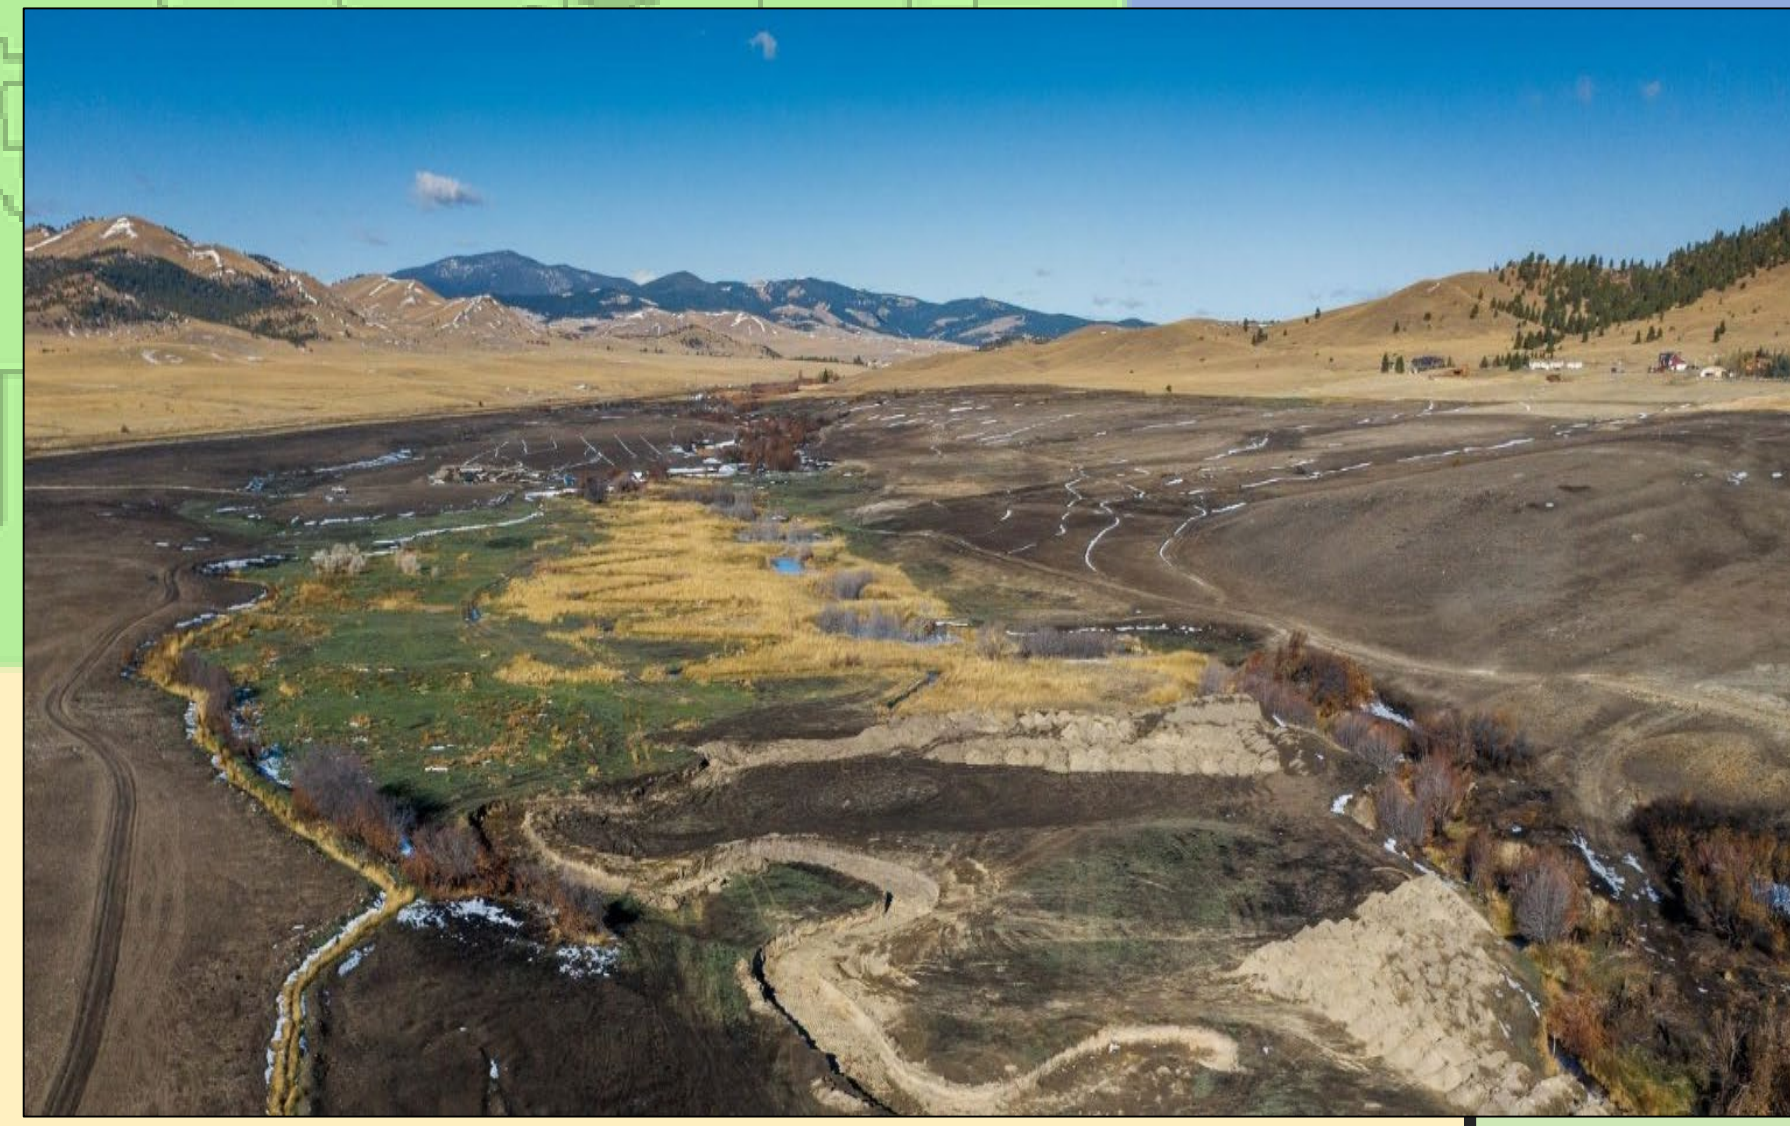
Sevenmile Creek, located northwest of Helena, Montana. Above photo from Prickly Pear Land Trust after channel restoration in Reach 3 in 2018.

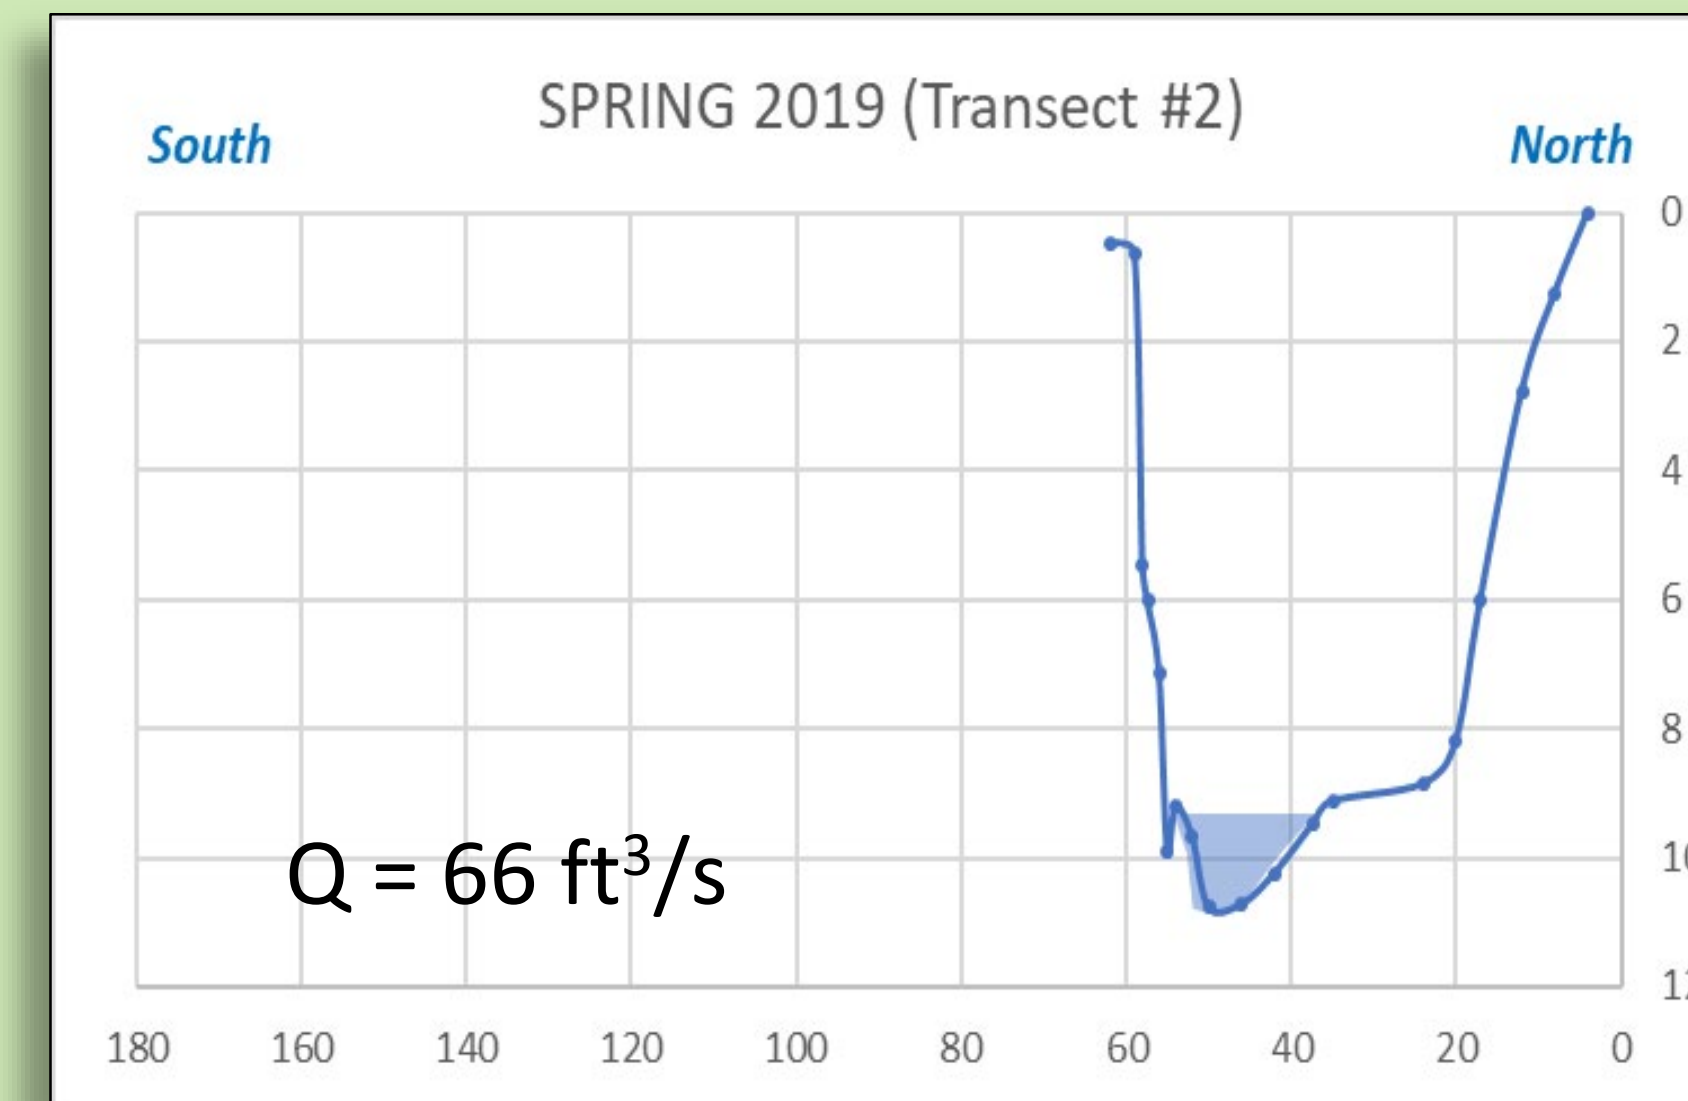
Figure 1. Deeply incised channel of Reach 4 Sevenmile Creek before restoration (Q=discharge)

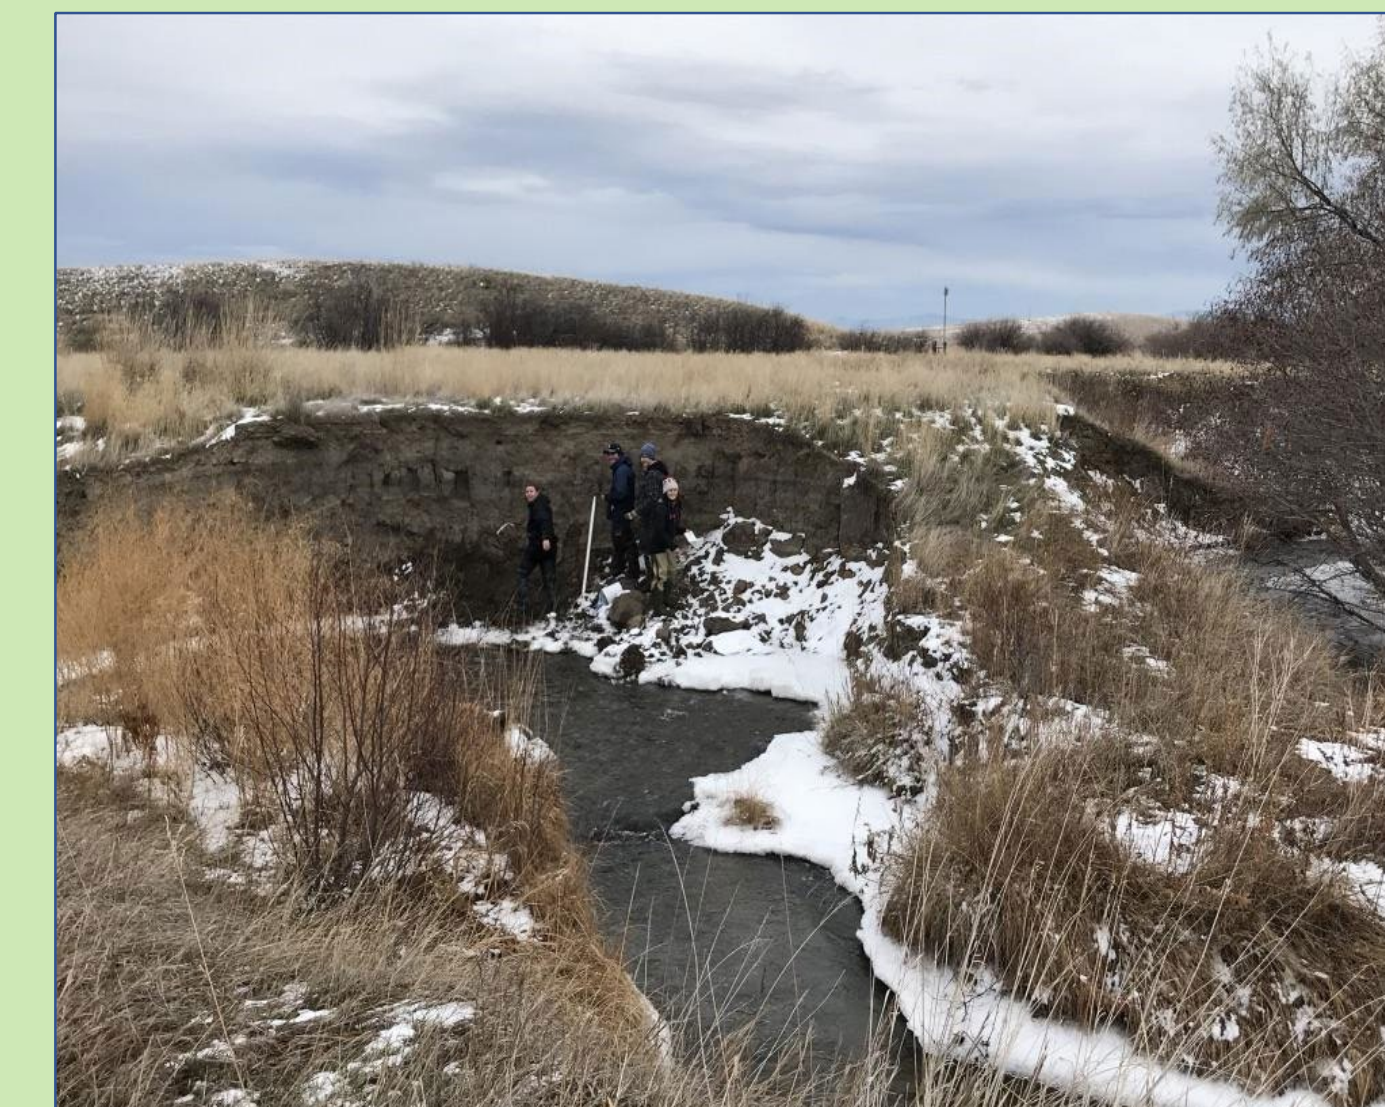
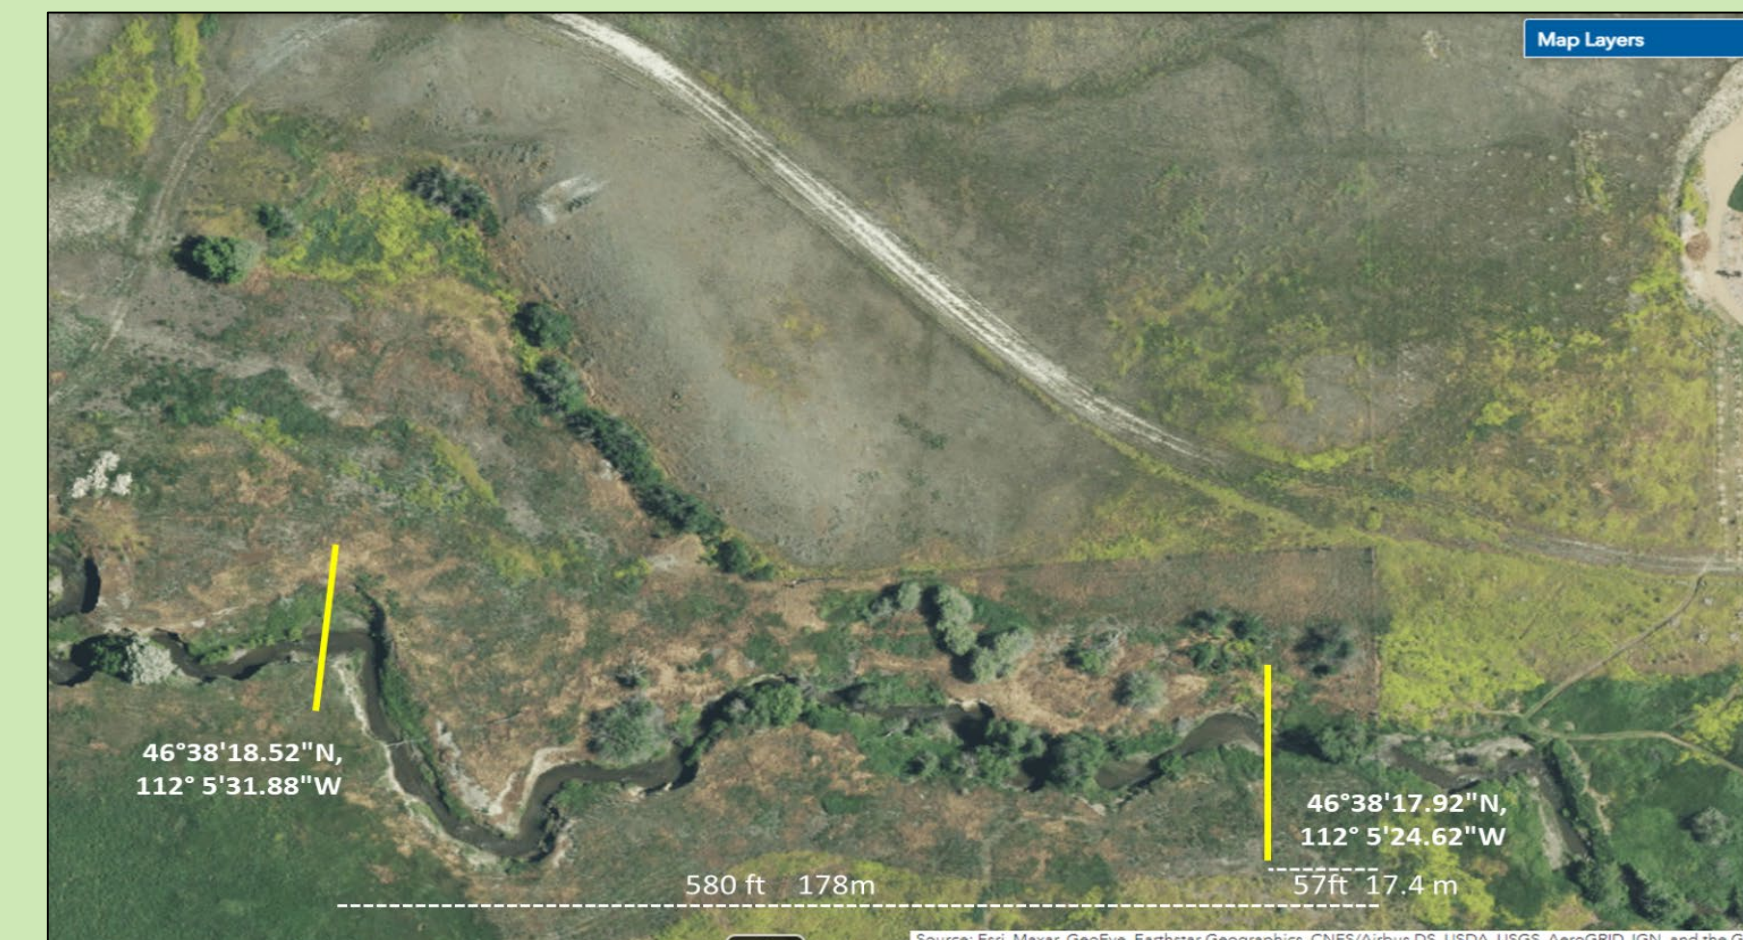
Figure 2. Location of Reach 4 survey transect before restoration efforts

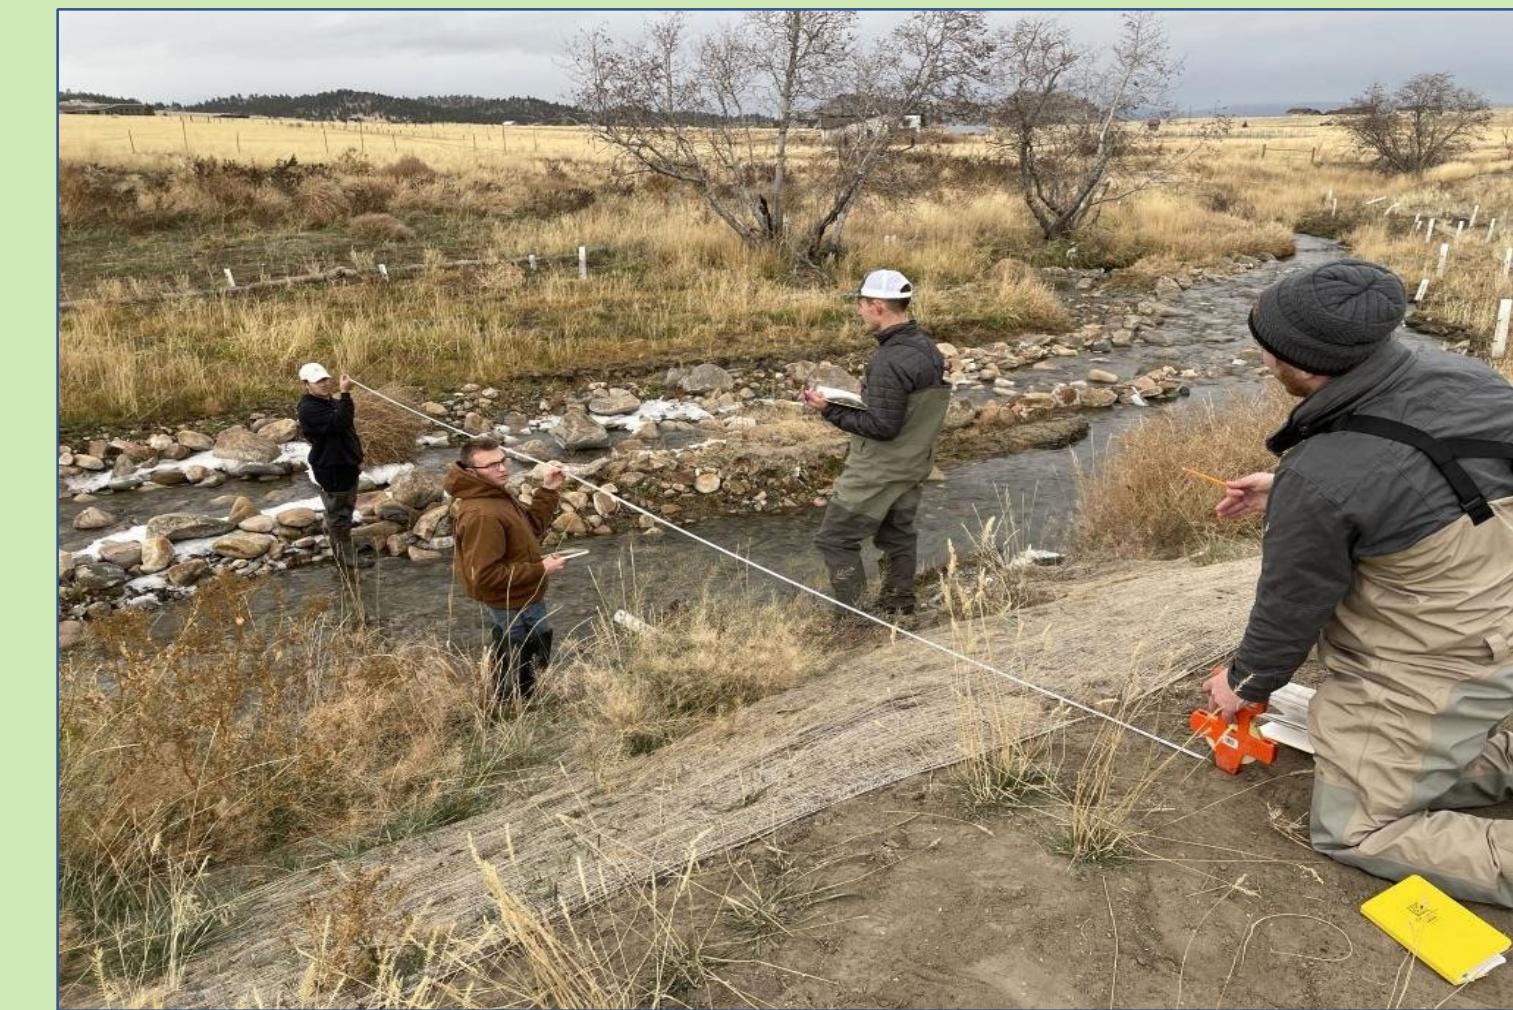
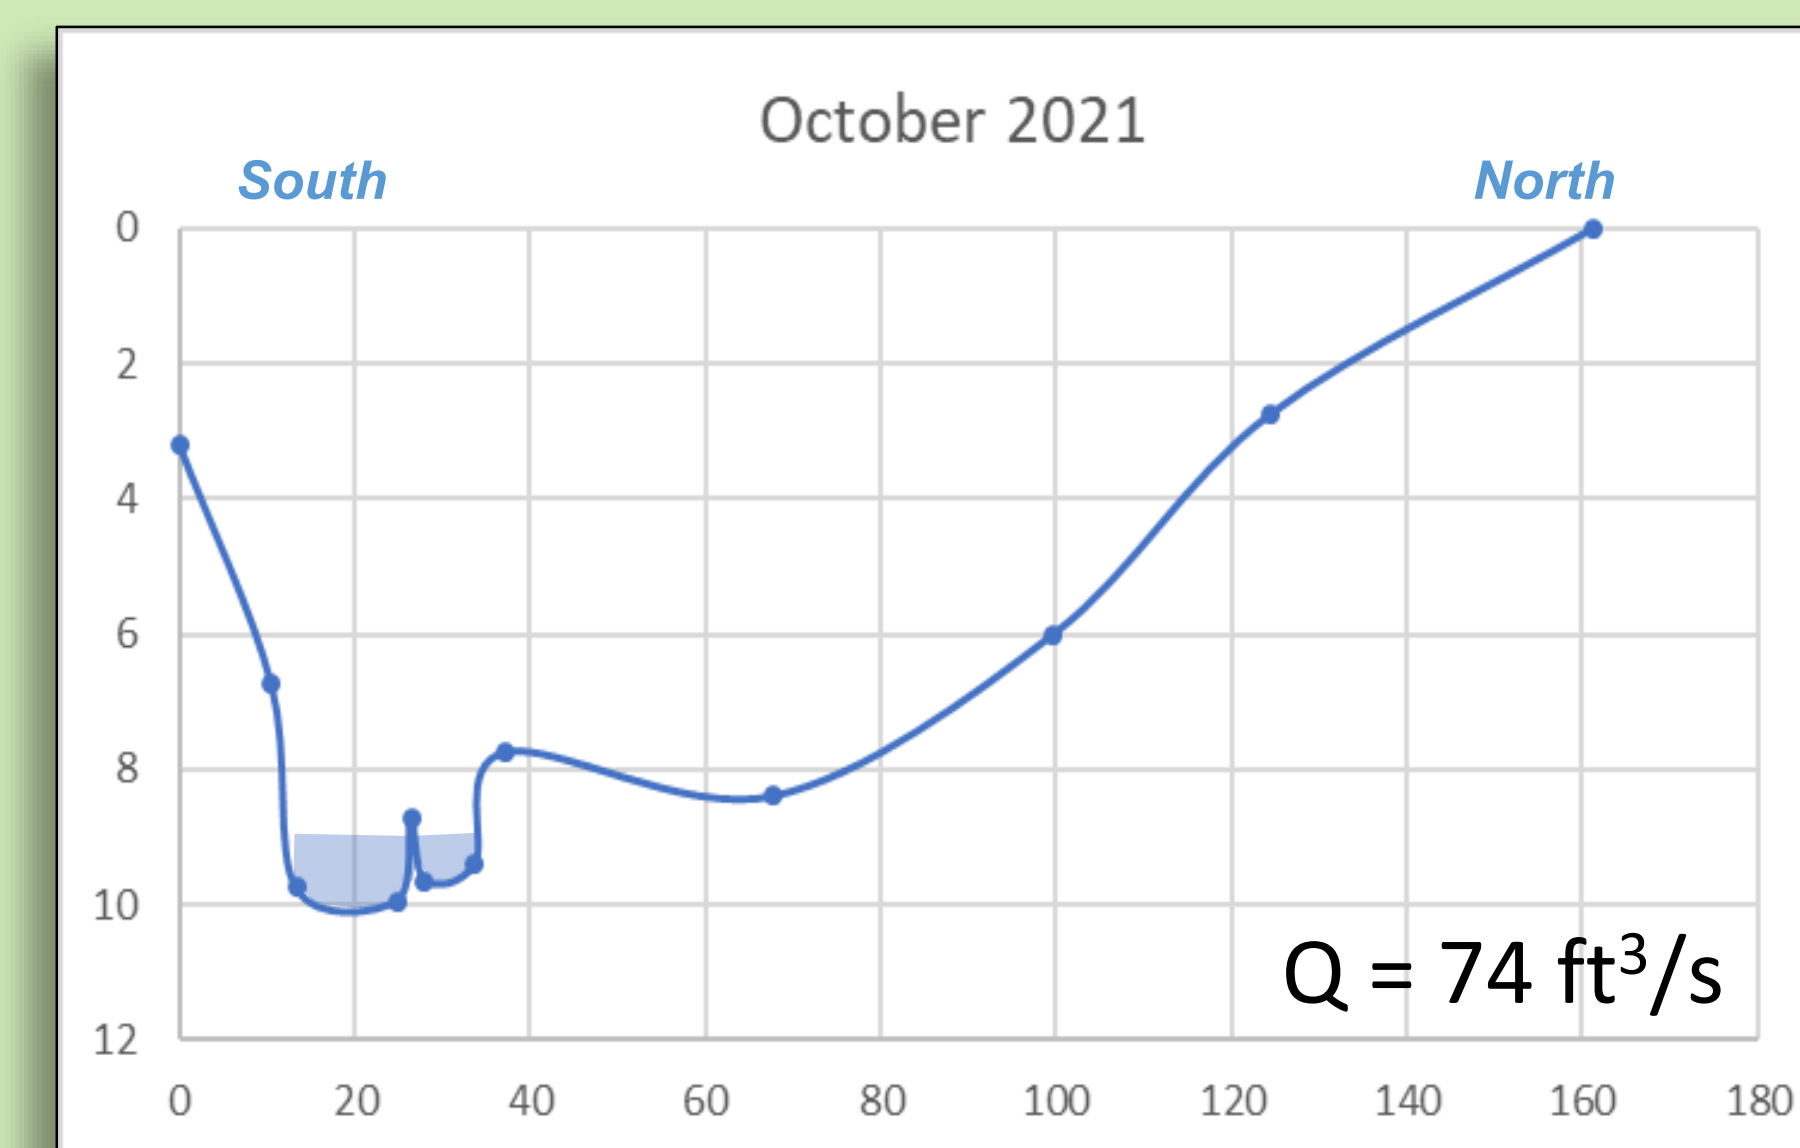
Figure 3. Sevenmile Creek channel profile after 2020 restoration, and after spring flooding in 2021 caused the channel to avulse and deepen (below).

- Sevenmile Creek has been returned to its natural floodplain in the lower reaches and the incised channels infilled or turned into ponds.
- The avulsed stream channel was regraded and has remained there so far.
- Although this project aimed to monitor spring flooding and channel changes in 2022, no floods have occurred yet.
- This study provides a baseline for the continued observation and longer term monitoring of the Sevenmile restoration efforts.

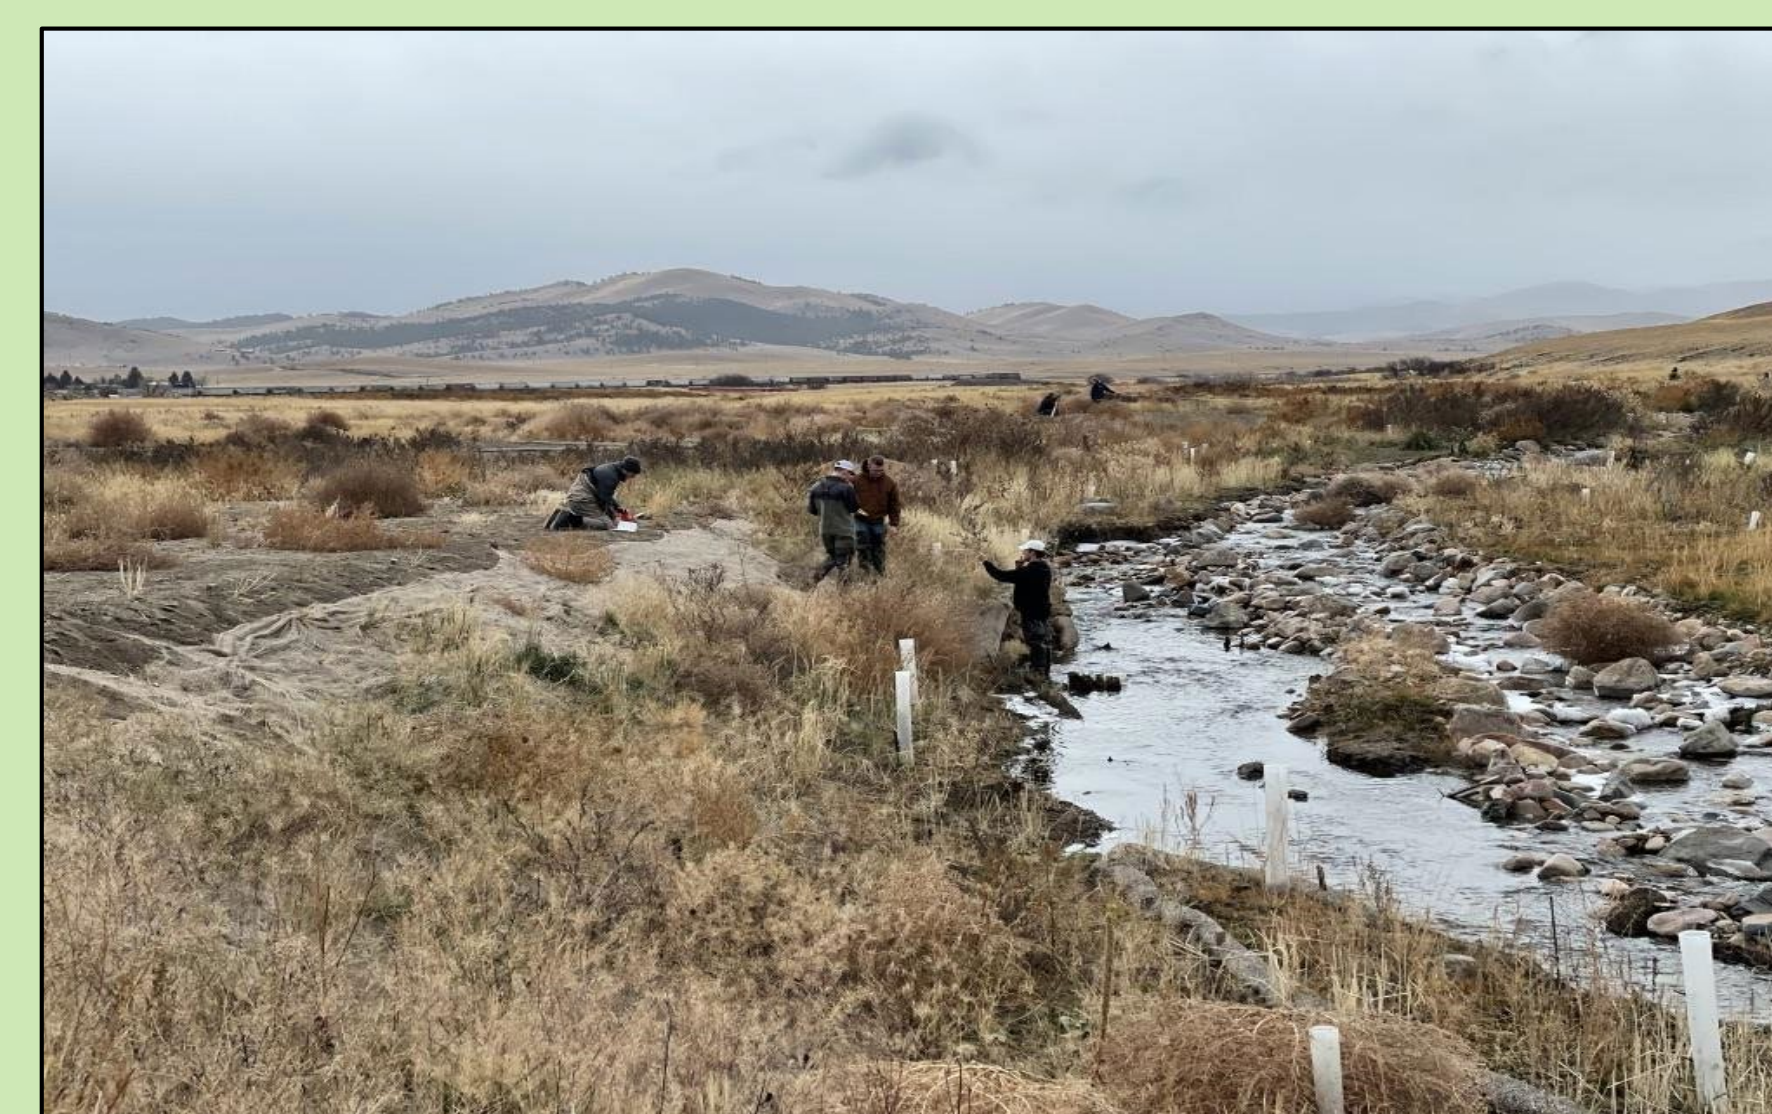
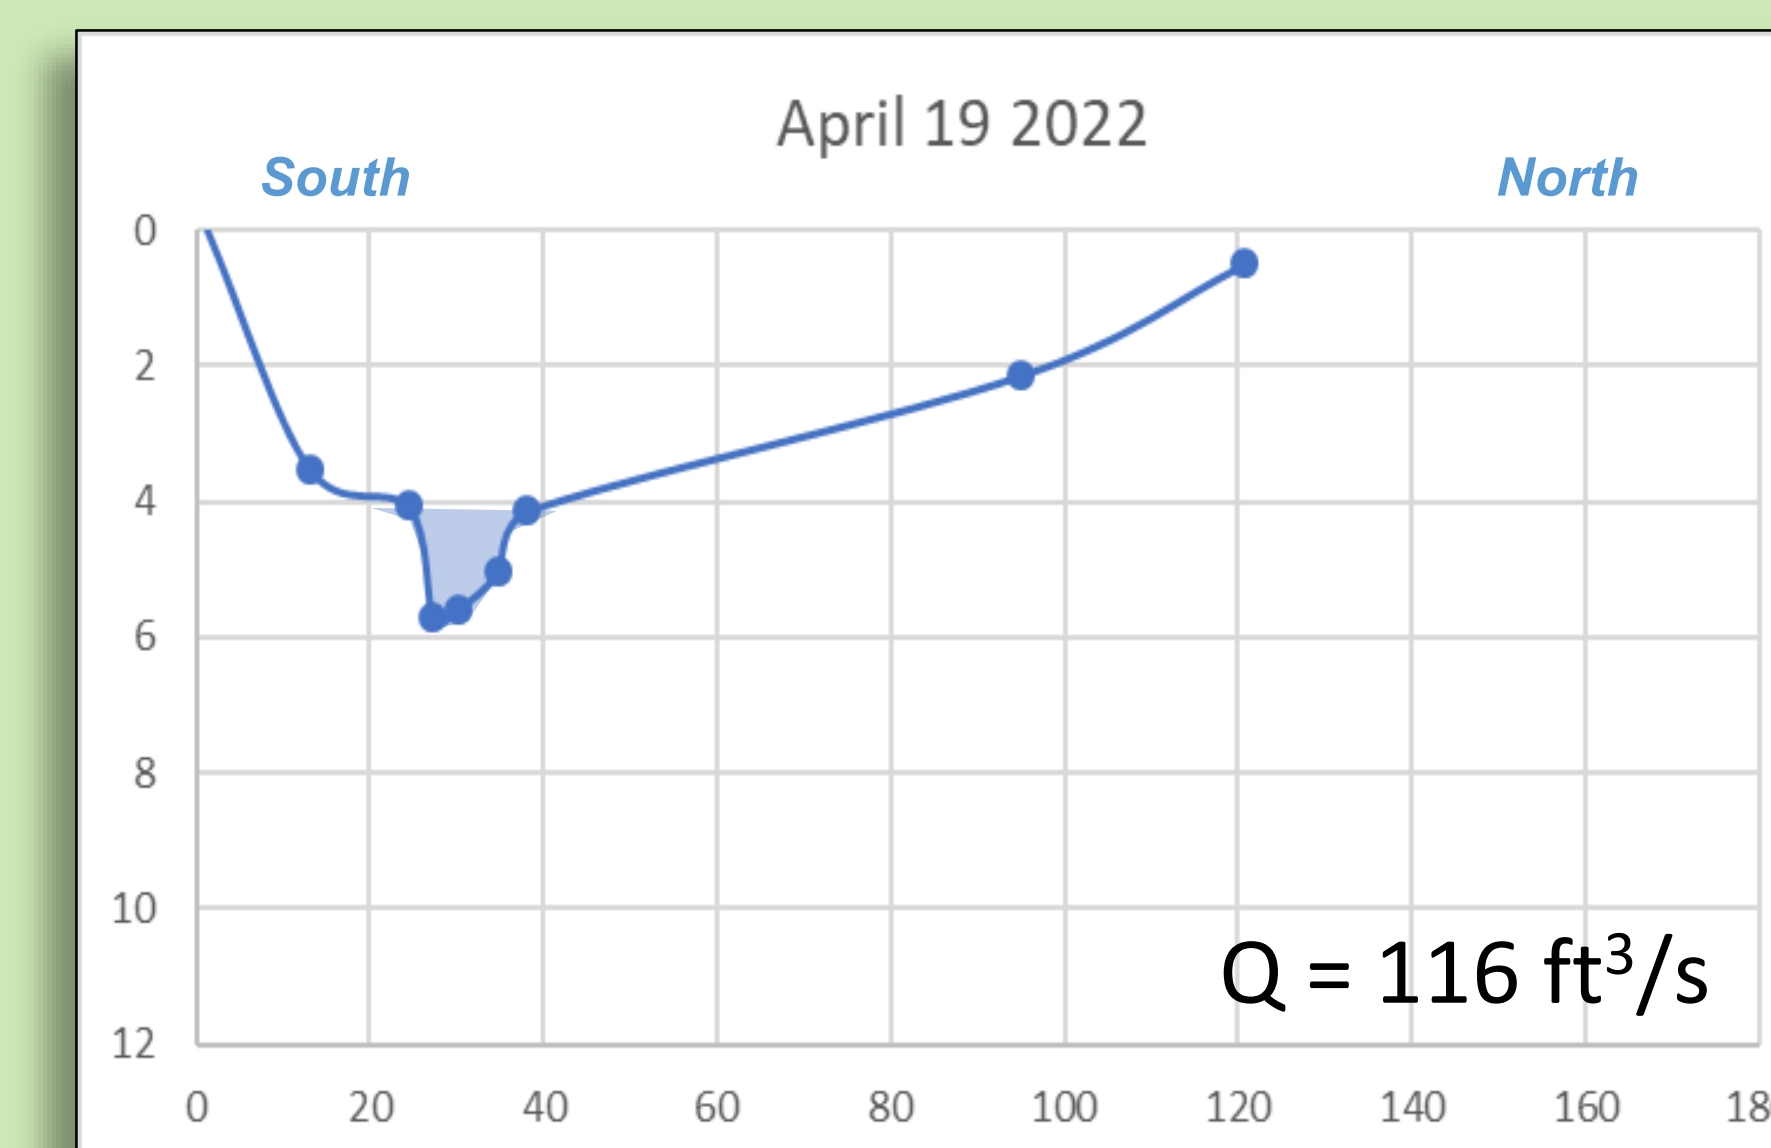
Figure 4. Stream channel profile after the restoration 'repair' and regrading work completed in spring 2022 (below).
